# YOUR INSPECTION REPORT

53 Bolton Dr.  
Mississauga, ON

Wednesday, January 17, 2024

Report No. 1735, v.2

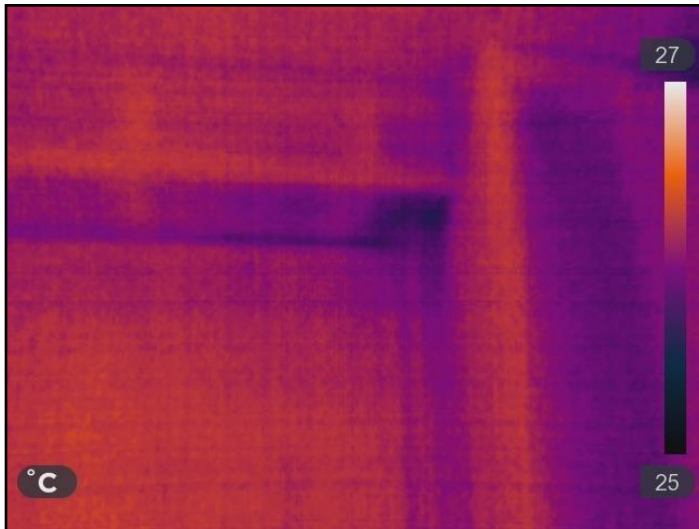
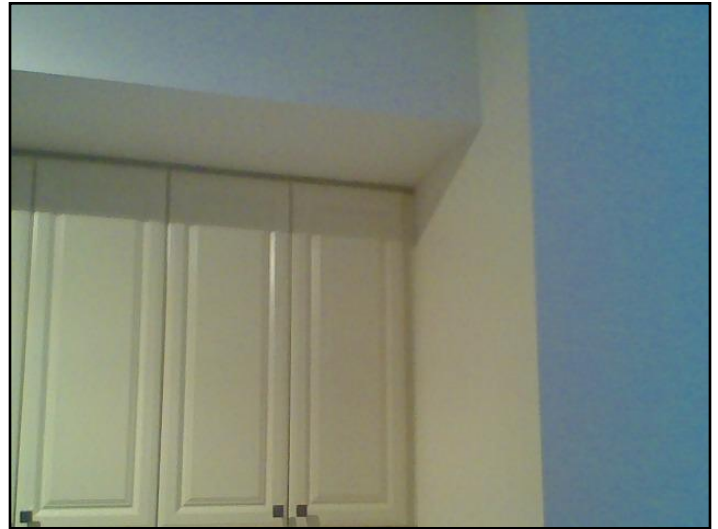
1. kitchen cabinet corner

**1. Condition:** • Cold Spots/areas

**Implication(s):** Increased heating and cooling costs, Reduced comfort

**Location:** Living Room Bedroom

**Task:** Proper sealing / adding insulation

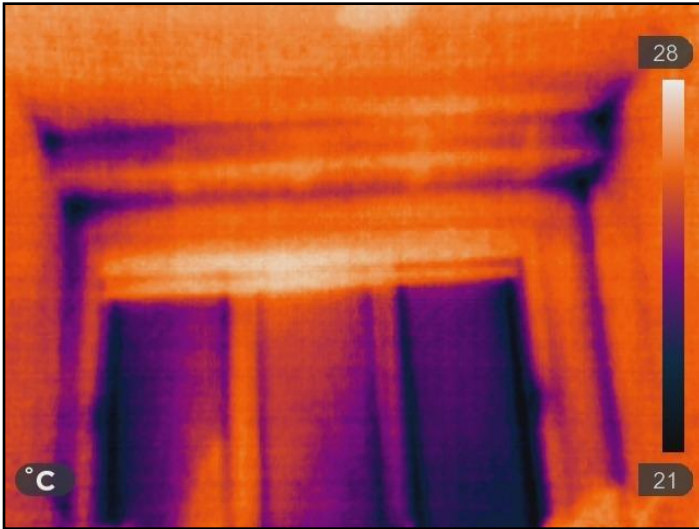
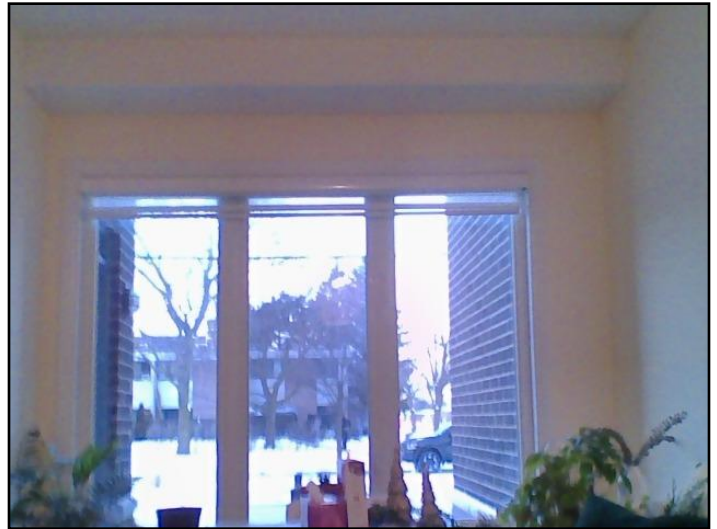
9. Living room

**2. Condition:** • Air infiltration

**Implication(s):** Increased heating and cooling costs, Reduced comfort

**Location:** Living Room Bathroom/Washroom

**Task:** Provide caulking/sealing and adequate insulation

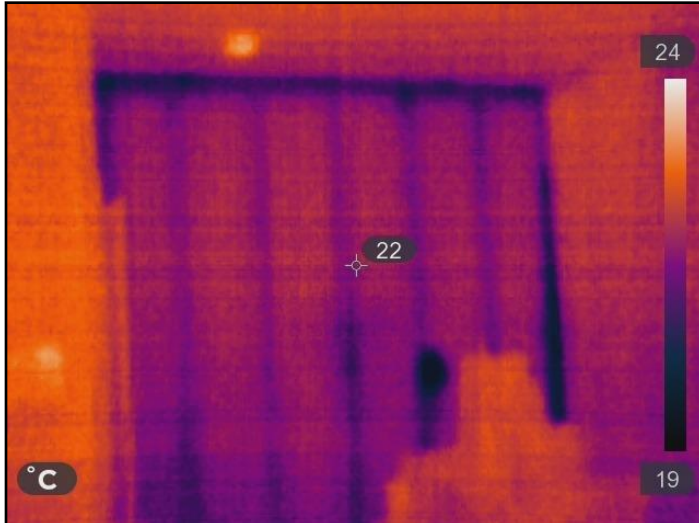
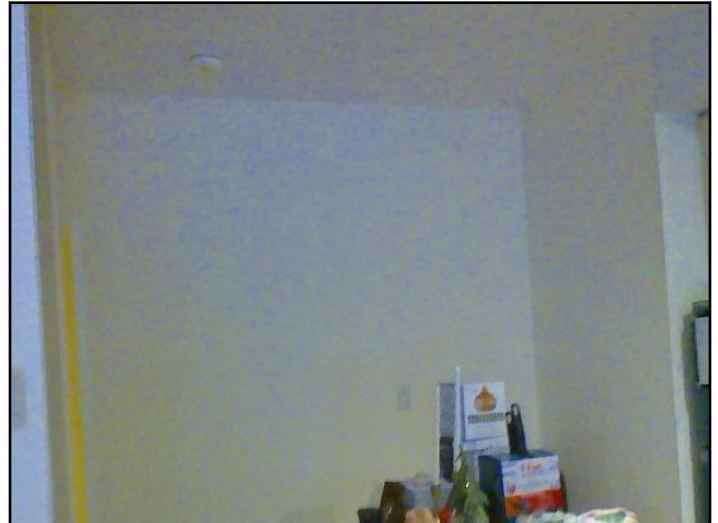
**3. Condition:** • Thermal bridging

**Implication(s):** Increased heating and cooling costs, Reduced comfort

17. Typical thermal bridge - Kitchen south wall

**Task:** Provide caulking/sealing and adequate insulation

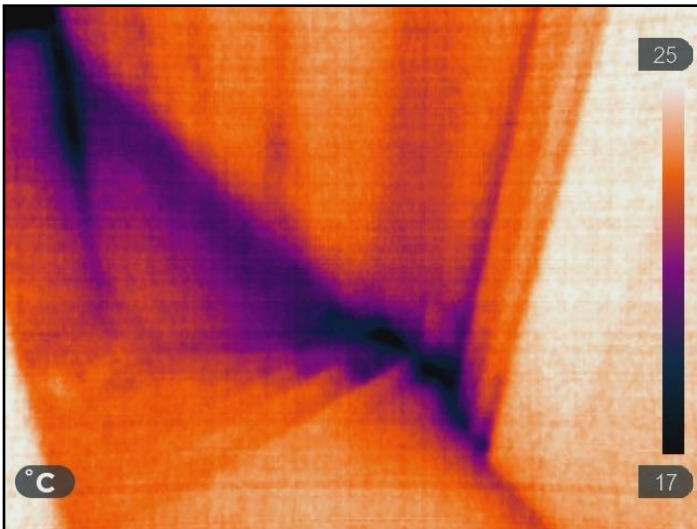
19. Typical thermal bridge at grade level

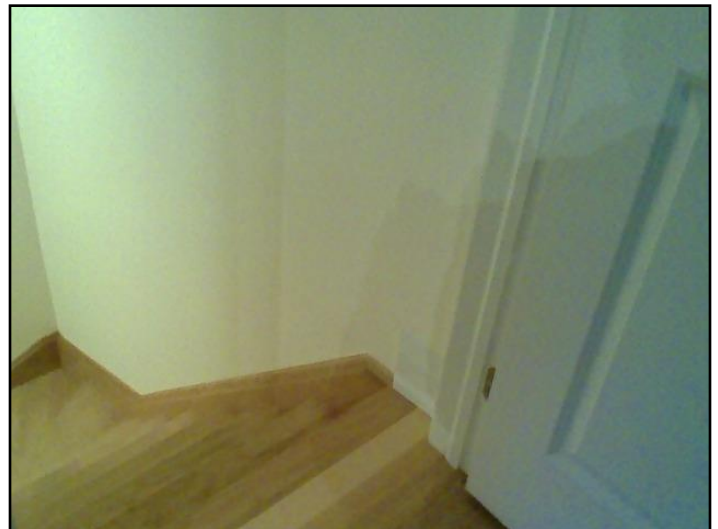
20. stairs to basement

**Location:** Living Room / Staircase

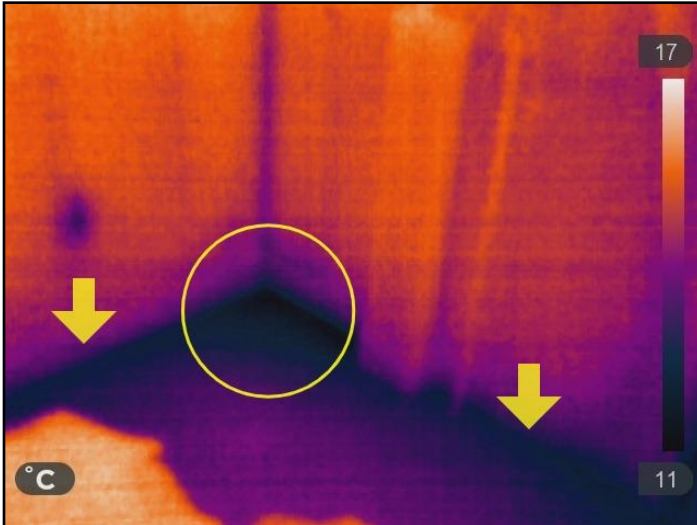
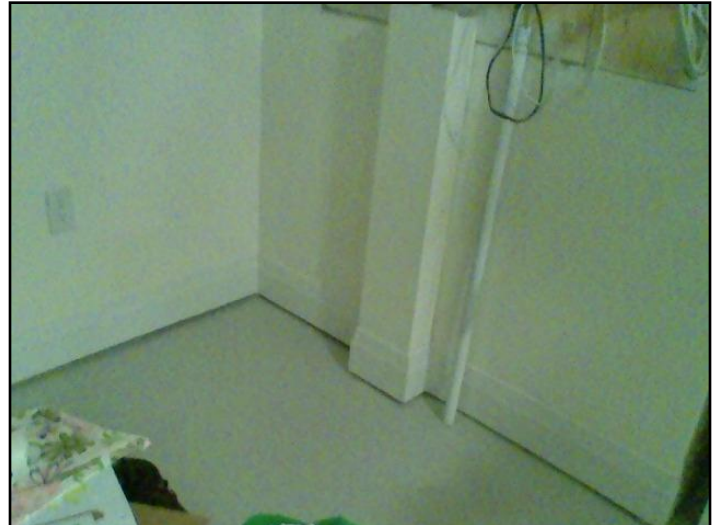
**4. Condition:** • Inadequate Insulation

**Implication(s):** Increased heating and cooling costs, Reduced comfort

**Location:** Various Basement

21. Inadequate Insulation

**Task:** Proper sealing / adding insulation

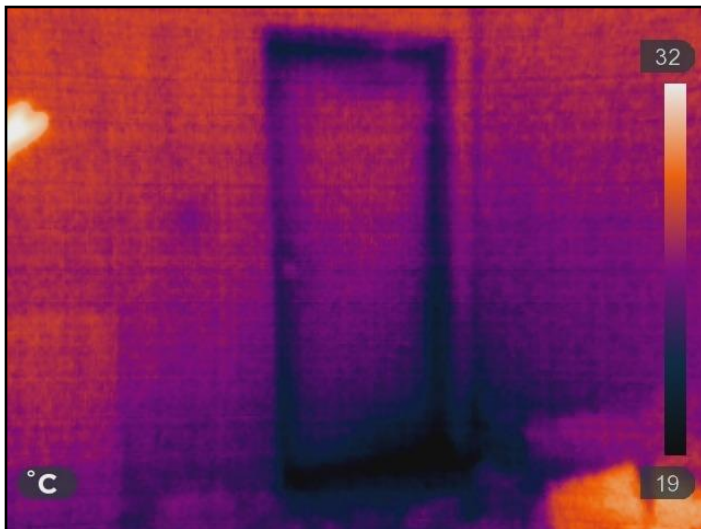
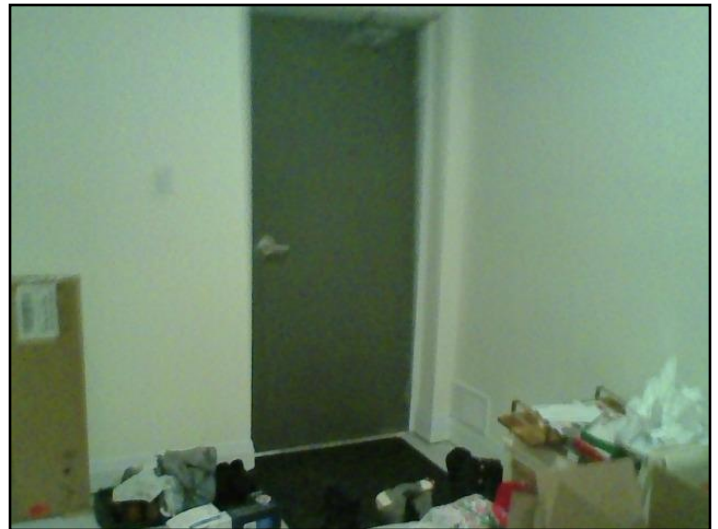
**5. Condition:** • Weather stripping ineffective

**Implication(s):** Increased heating and cooling costs, Reduced comfort.

**Location:** Basement

25. Weather stripping ineffective

**Task:** Repair or replace weather stripping
