# INSPECTION REPORT

For the Property at:  
**382 NELSON ST**  
MISSISSAUGA, ON

Prepared for: TIM HOPKINS  
Inspection Date: Friday, April 6, 2007  
Prepared by: Kersi Shastri

RE: Report No. 1002, v.3  
382 Nelson St  
Mississauga, ON

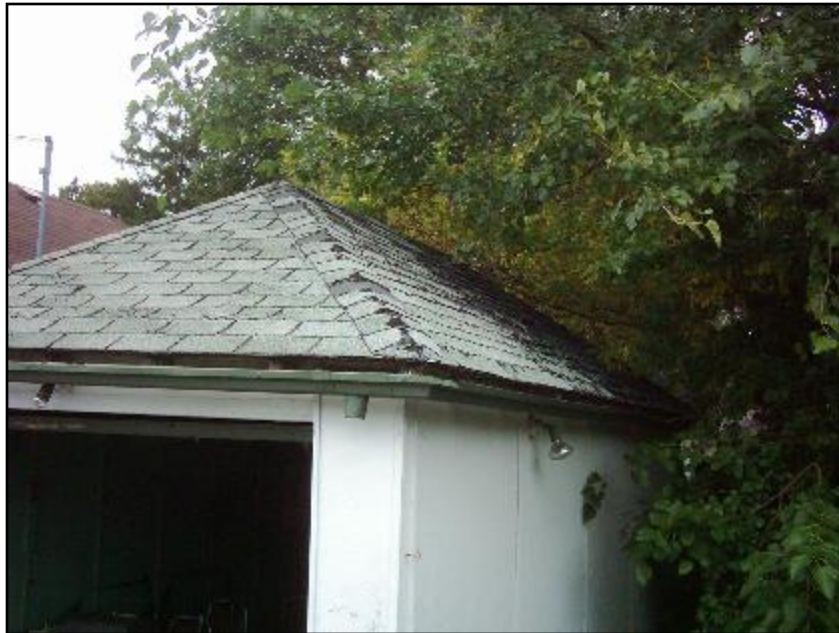
1.

### Sloped roofing \ Asphalt shingles

**Condition:** • [Old, worn out](#)

**Implication(s):** Chance of water damage to contents, finishes and/or structure

**Location:** North Garage

**Task:** Replace

**Time:** Less than 1 year

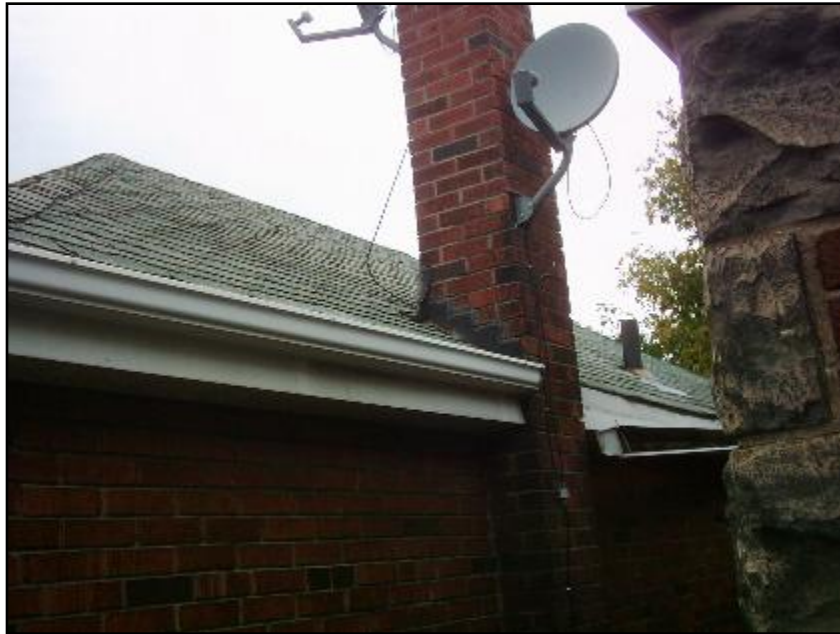
2.

### Sloped roofing \ Asphalt shingles

**Condition:** • [Old, worn out](#)

**Implication(s):** Chance of water damage to contents, finishes and/or structure

**Location:** Throughout

**Task:** Replace

**Time:** Immediate

**Cost:** \$4,000 - And up

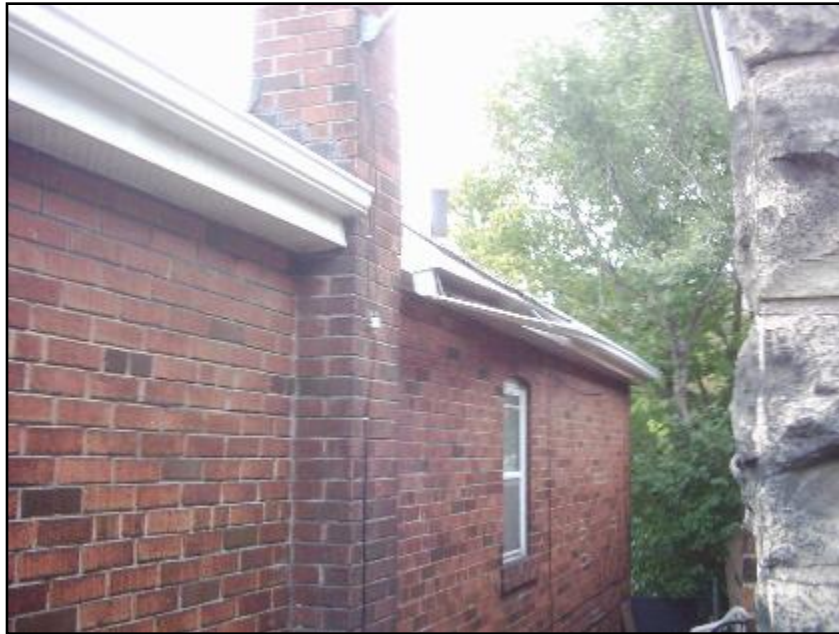
3.

### Roof drainage \ Downspouts

**Condition:** • [Damage](#)

**Implication(s):** Chance of water damage to contents, finishes and/or structure

**Location:** South

**Task:** Repair or replace

**Time:** Immediate

**Cost:** Depends on approach

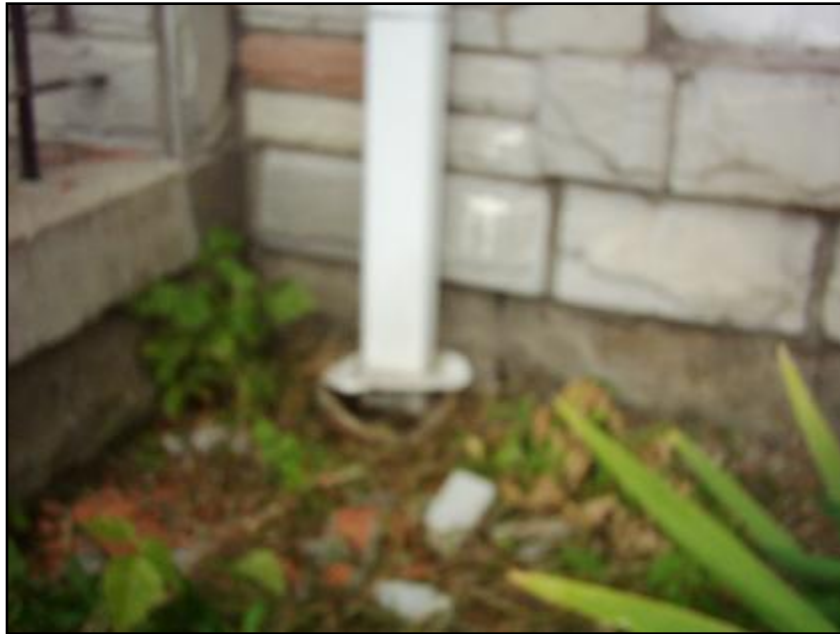
4.

### Roof drainage \ Downspouts

**Condition:** • [Missing](#)

**Implication(s):** Chance of water damage to contents, finishes and/or structure

**Location:** Garage

**Task:** Provide

**Time:** Less than 1 year

**Cost:** Less than \$100

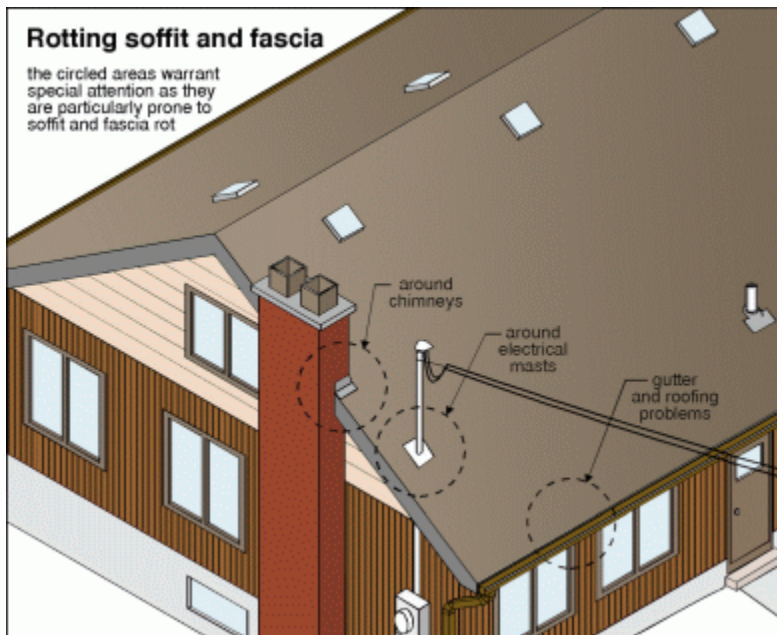
## Walls \ Soffits and fascia

**Condition:** • [Rot or insect damage](#)

**Implication(s):** Cosmetic defects | Chance of water damage to contents, finishes and/or structure | Material deterioration

**Location:** West (below electrical service mast)

**Task:** Repair

**Cost:** Depends on work needed

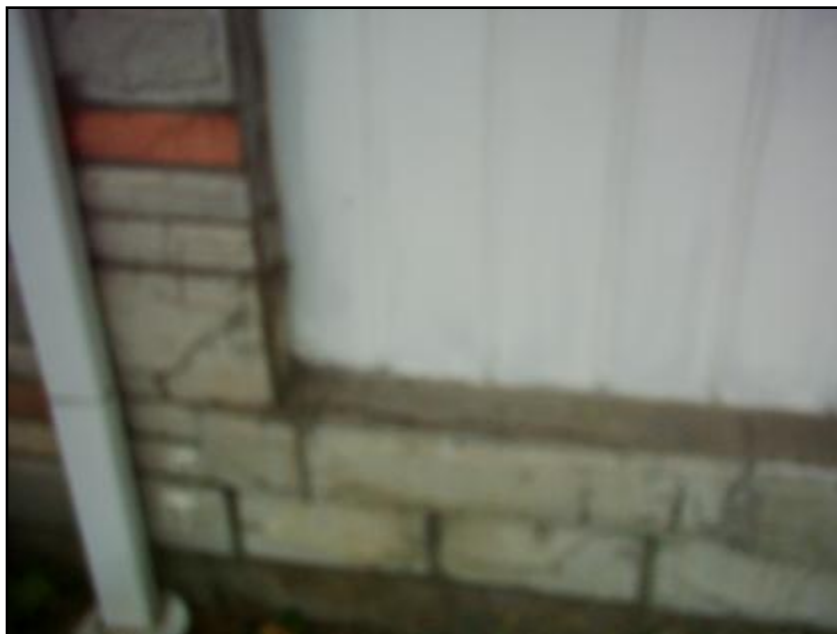
5.

## Walls \ Brick, stone and concrete

**Condition:** • [Cracked](#)

**Implication(s):** Chance of water entering house | Weakened structure | Chance of movement

**Location:** South

**Task:** Repair

**Time:** Less than 1 year

**Cost:** Depends on work needed

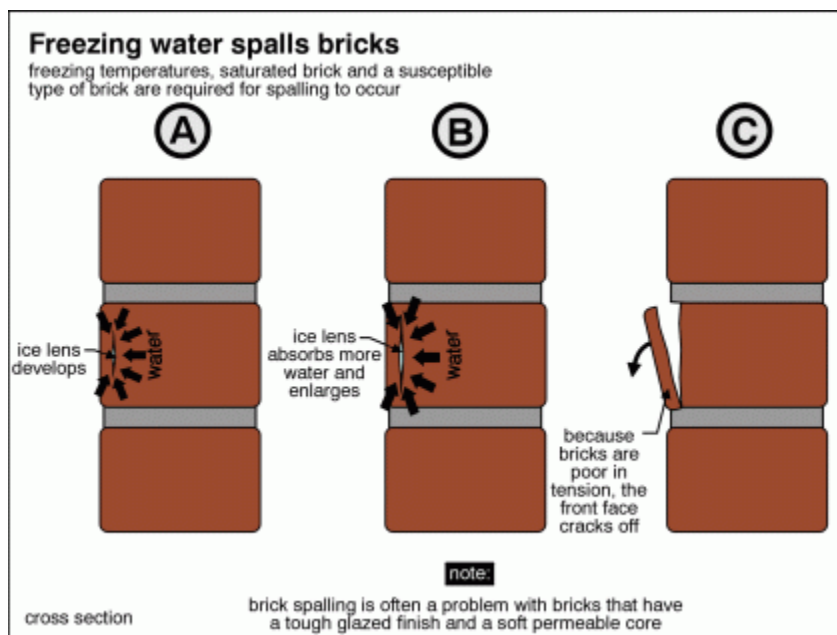
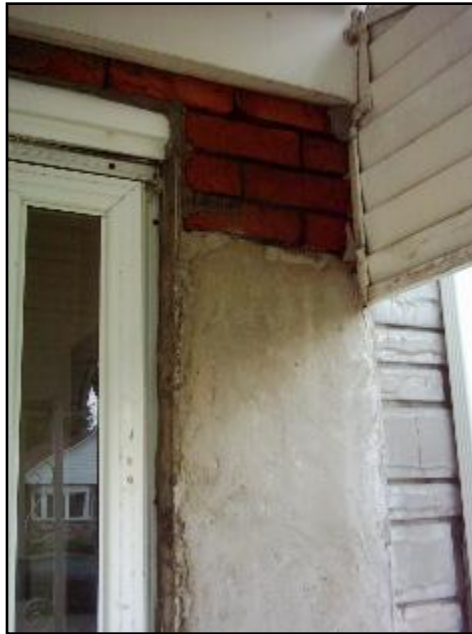
6.

### Walls \ Brick, stone and concrete

**Condition:** • [Spalling](#)

**Implication(s):** Cosmetic defects | Weakened structure | Chance of structural movement

**Location:** South

**Task:** Repair

**Time:** Less than 1 year

**Cost:** Depends on work needed

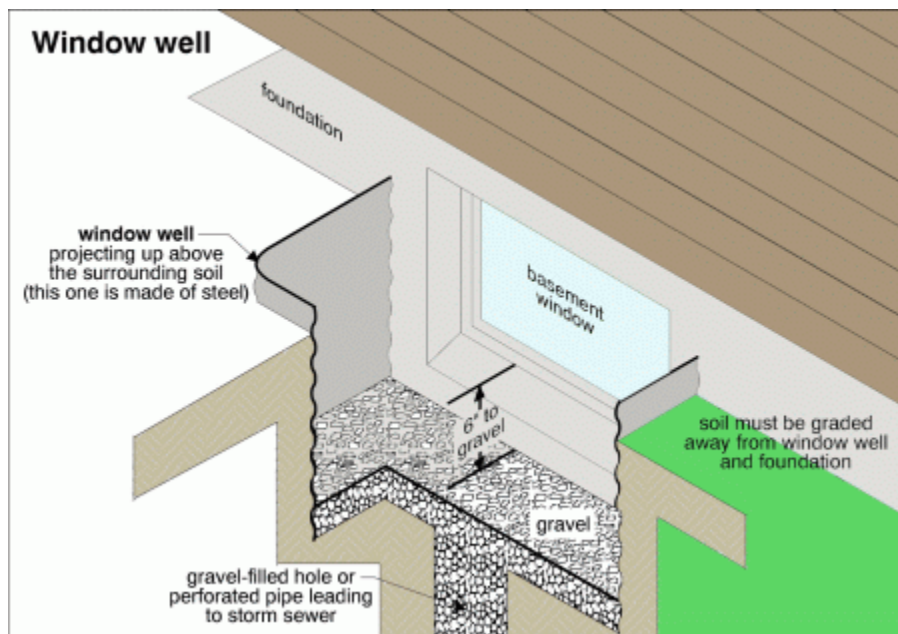
### Windows and skylights \ Window wells

**Condition:** • [Missing](#)

**Implication(s):** Chance of water damage to contents, finishes and/or structure | Material deterioration

**Location:** Throughout

**Task:** Provide

**Time:** Discretionary

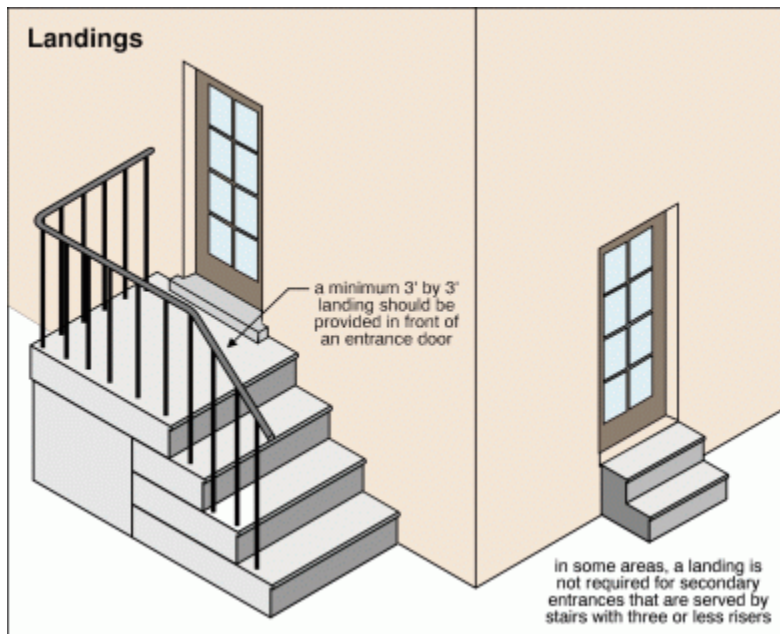
### Porches, decks, steps, patios and balconies \ Steps and landings

**Condition:** • [Landings missing or undersized](#)

**Implication(s):** Trip or fall hazard

**Location:** North First floor

**Task:** Provide

**Time:** Immediate

**Cost:** Depends on approach

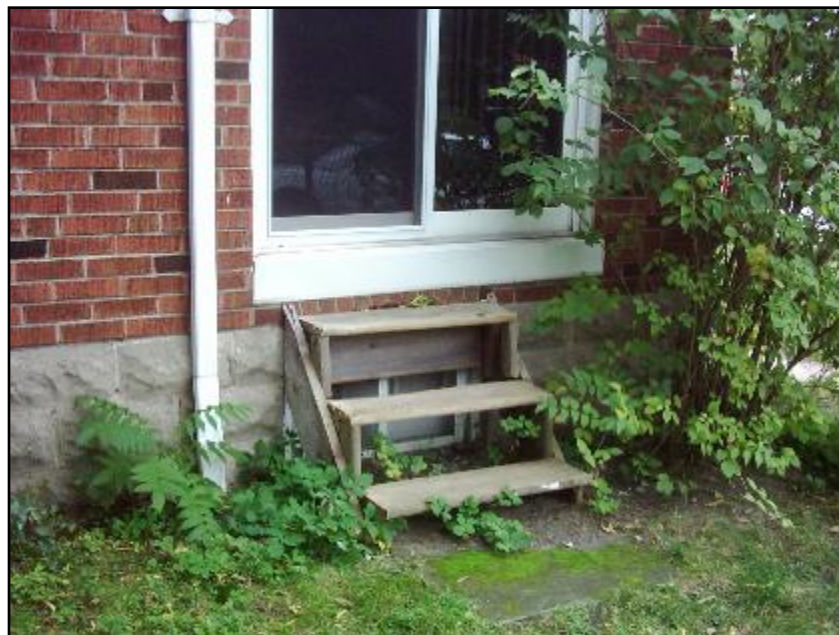
7.

**Porches, decks, steps, patios and balconies \ Steps and landings**

**Condition:** • [Wood/soil contact](#)

**Implication(s):** Shortened life expectancy of material | Material deterioration

**Location:** North

**Task:** Repair or replace

**Cost:** Regular maintenance item

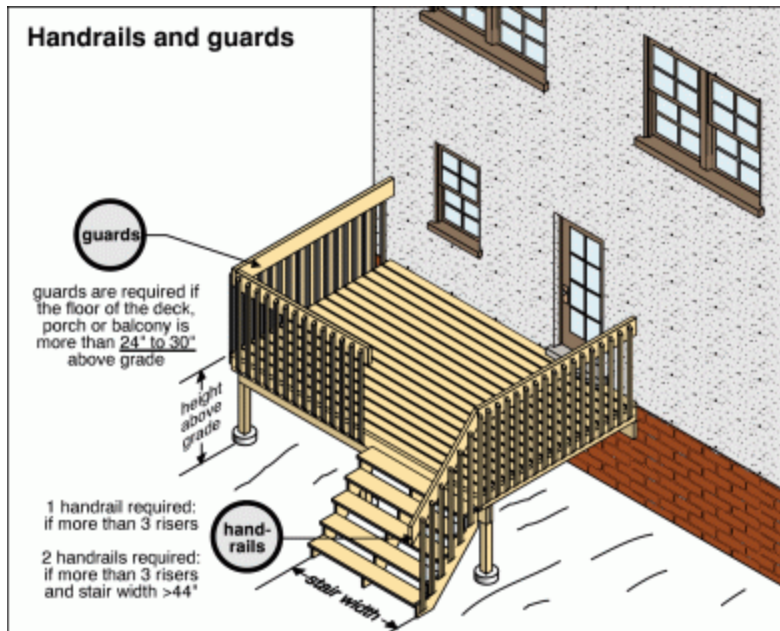
## Porches, decks, steps, patios and balconies \ Handrails and guards

**Condition:** • [Missing](#)

**Implication(s):** Fall hazard

**Location:** North

**Task:** Provide

**Time:** Immediate

**Cost:** Depends on work needed

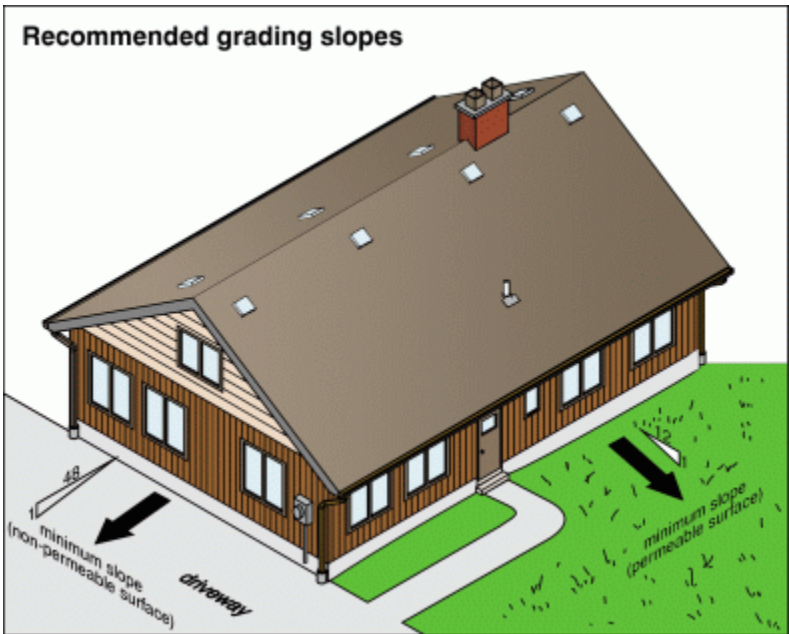
## Landscaping \ Walk and driveway

**Condition:** • [Cracked or damaged surfaces](#)

**Implication(s):** Trip or fall hazard

**Location:** North Garage

**Task:** Repair or repave

**Time:** Regular maintenance

**Cost:** Depends on approach

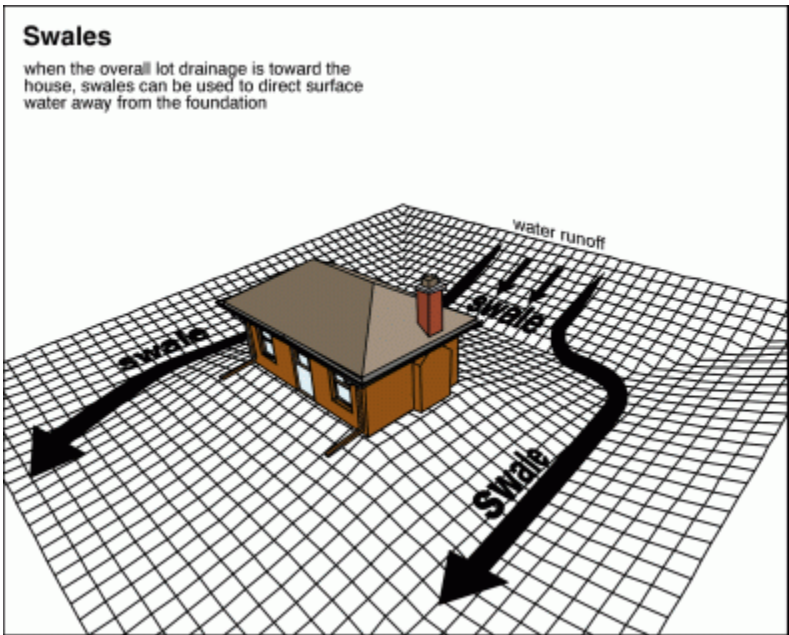
## Landscaping \ Walk and driveway

**Condition:** • [Improper slope or drainage](#)

**Implication(s):** Chance of water damage to contents, finishes and/or structure

**Location:** East

**Task:** Provide

**Time:** Regular maintenance

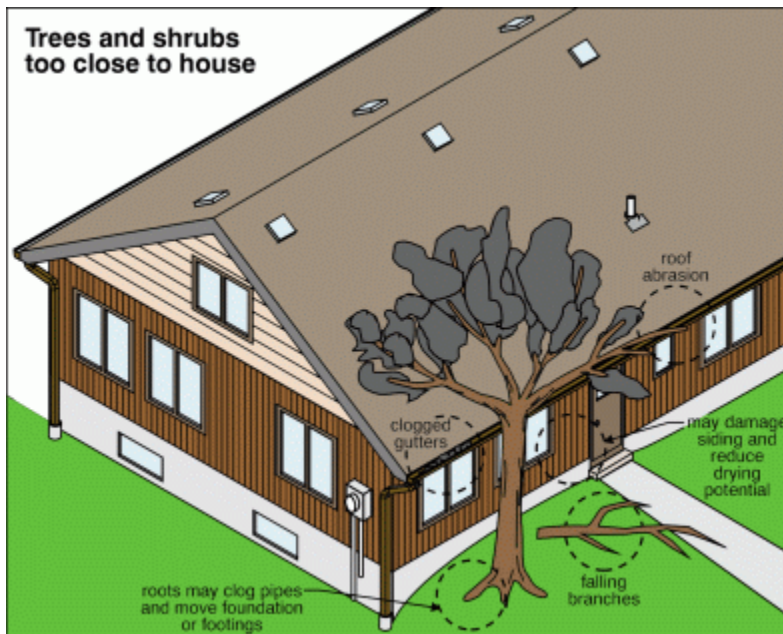
### Landscaping \ General

**Condition:** • [Trees or shrubs too close to house](#)

**Implication(s):** Chance of water damage to contents, finishes and/or structure | Chance of pests entering house | Material deterioration

**Location:** Throughout

**Task:** Clean

**Cost:** Regular maintenance item

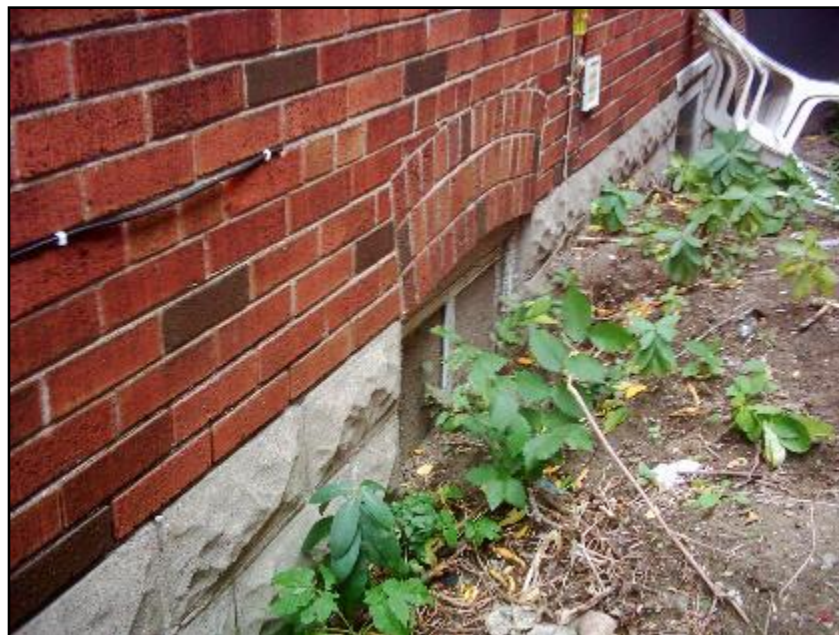
8.

## Landscaping \ General

**Condition:** • [Too close to grade or wood/soil contact](#)

**Implication(s):** Chance of water entering house | Weakened structure | Rot | Insect damage

**Location:** Throughout Basement

**Task:** Correct

**Cost:** Regular maintenance item

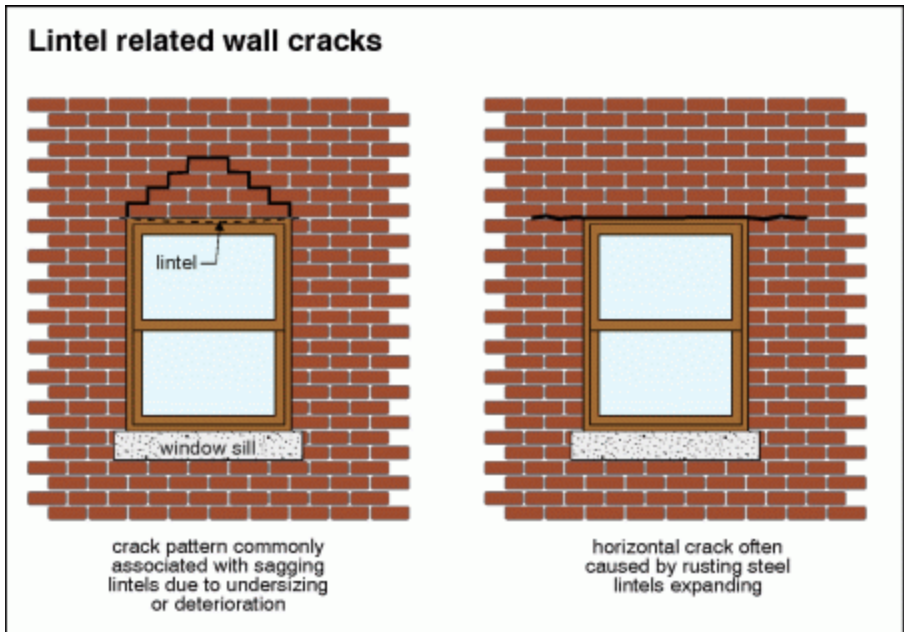
- Walls \ Lintels**
- Condition:** • [Rust](#)
- Implication(s):** Weakened structure | Chance of structural movement
- Location:** East Basement
- Task:** Repair
- Time:** Regular maintenance
- Cost:** Regular maintenance item

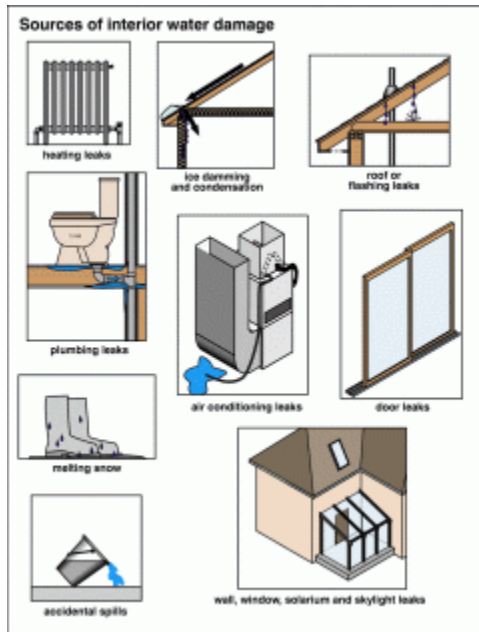
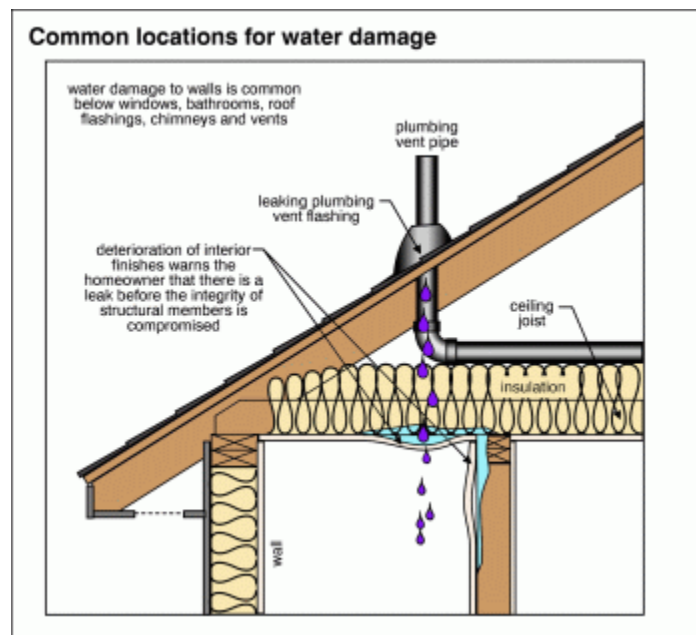
**Condition:** • [Water damage](#)

**Implication(s):** Cosmetic defects

**Task:** Repair

**Time:** Less than 1 year

**Cost:** Depends on work needed

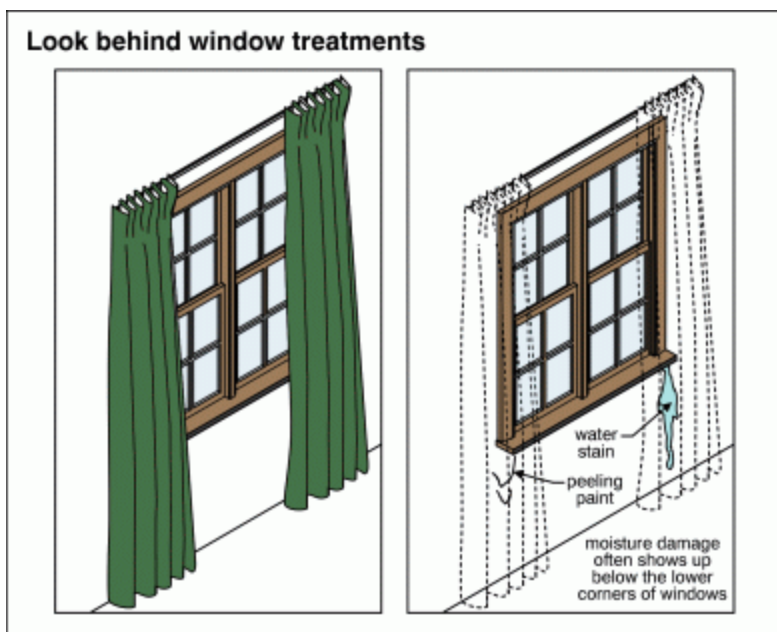
**Condition:** • [Water leaks](#)

**Implication(s):** Chance of damage to finishes and structure | Chance of damage to structure

**Task:** Repair

**Time:** Less than 1 year

**Cost:** Depends on work needed

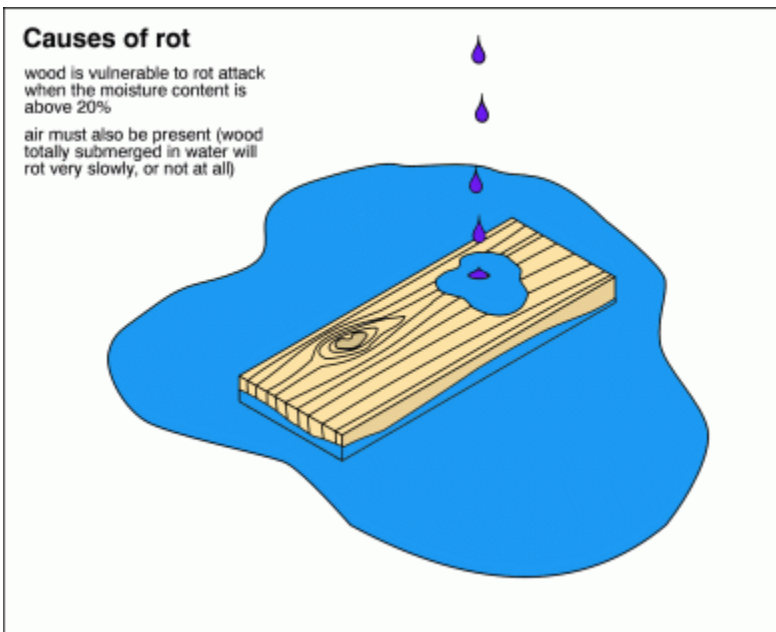
## Windows \ Frames

**Condition:** • [Rot](#)

**Implication(s):** Cosmetic defects | Chance of damage to structure | Material deterioration

**Task:** Repair or replace

**Time:** Discretionary

**Cost:** Depends on work needed

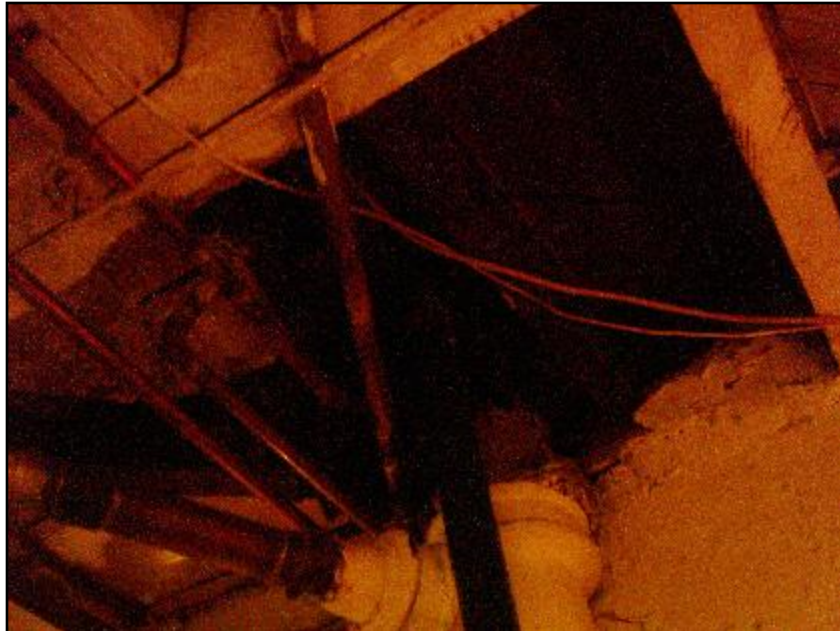
10.

**Condition:** • [Rot](#)

**Implication(s):** Cosmetic defects | Material deterioration | Damage or physical injury due to falling materials

**Task:** Repair

**Time:** Less than 1 year

**Cost:** Depends on work needed
